USS IWO JIMA Mishap

A Set-up for Failure

Bryan O'Connor
Chief,
Office of Safety and Mission Assurance
NASA Headquarters, Washington, DC
OSMA POC, Brian Hughitt (202) 358-1572

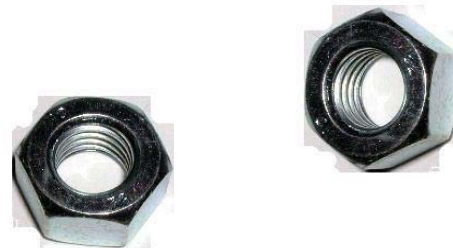
Unauthorized substitution of black oxide coated brass fasteners (BOCBF) for high strength steel fasteners in the valve

Alloy Steel Nuts

Black Oxide Coated Nuts
(not actual BOCBF)

- Identified all BOCBF substitution hazards on Navy ships
- Mass inspection of in-service fasteners (scrape or magnet)
- Purged stocks & replaced with shiny brass or monel fasteners
- Revise parts lists to flag Level I fasteners and include warning notes
- Training curricula modified to include Level I awareness (engineers and mechanics)
- Fastener Selection training video disseminated Navy-wide
